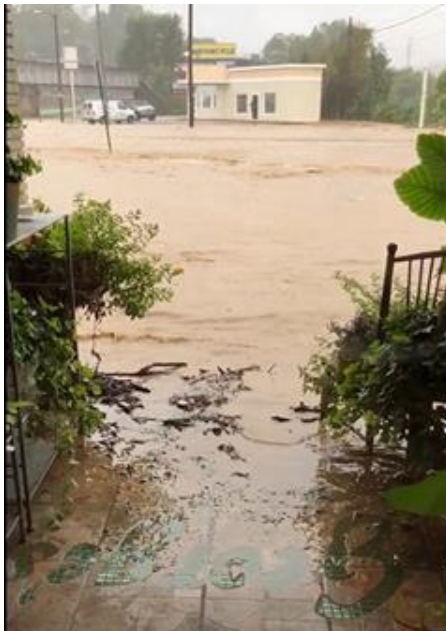
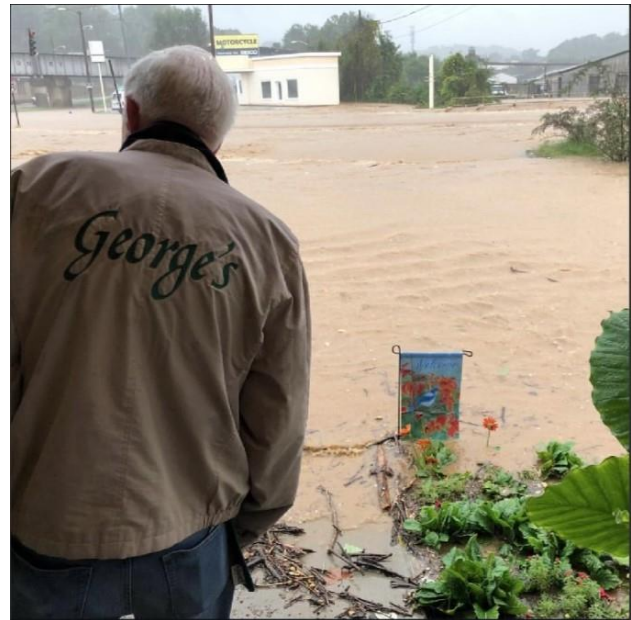
*Figure 1 – Standing in front door of 1953 Franklin Rd. SW facing intersection of Brandon Ave. and Franklin Rd. SW. (A) floodwaters approaching front door and (B) floodwaters begin to enter side door.*

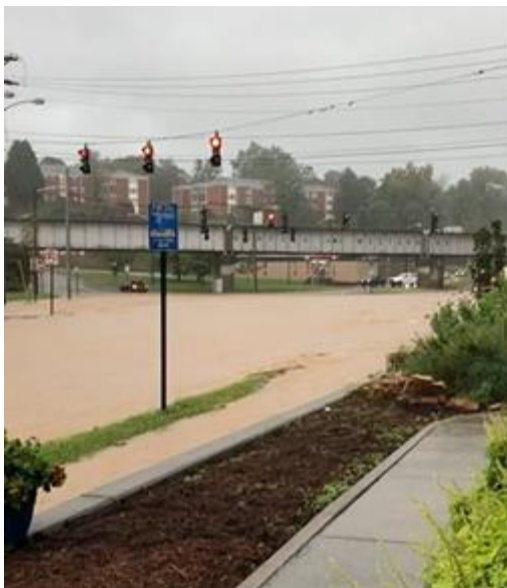
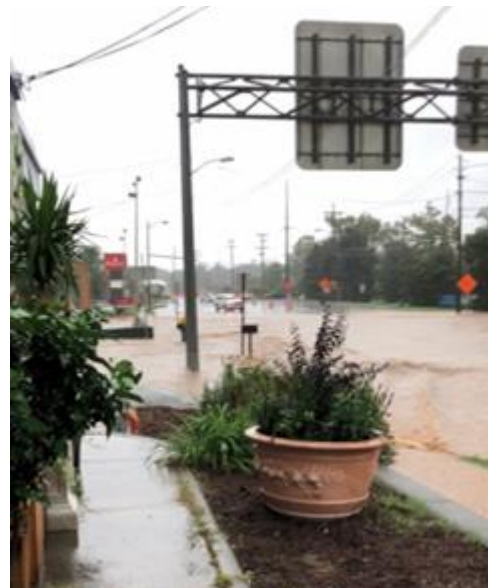
*Figure 2 – Standing on sidewalk along Franklin Rd. SW in front of 1953 Franklin Rd. SW facing (A) Brandon Ave./Franklin Rd. SW intersection and (B) northbound Franklin Rd. Floodwaters encroaching on 1941 Franklin Rd. SW can be seen in (B) as water moves off the road to the left of the photograph.*

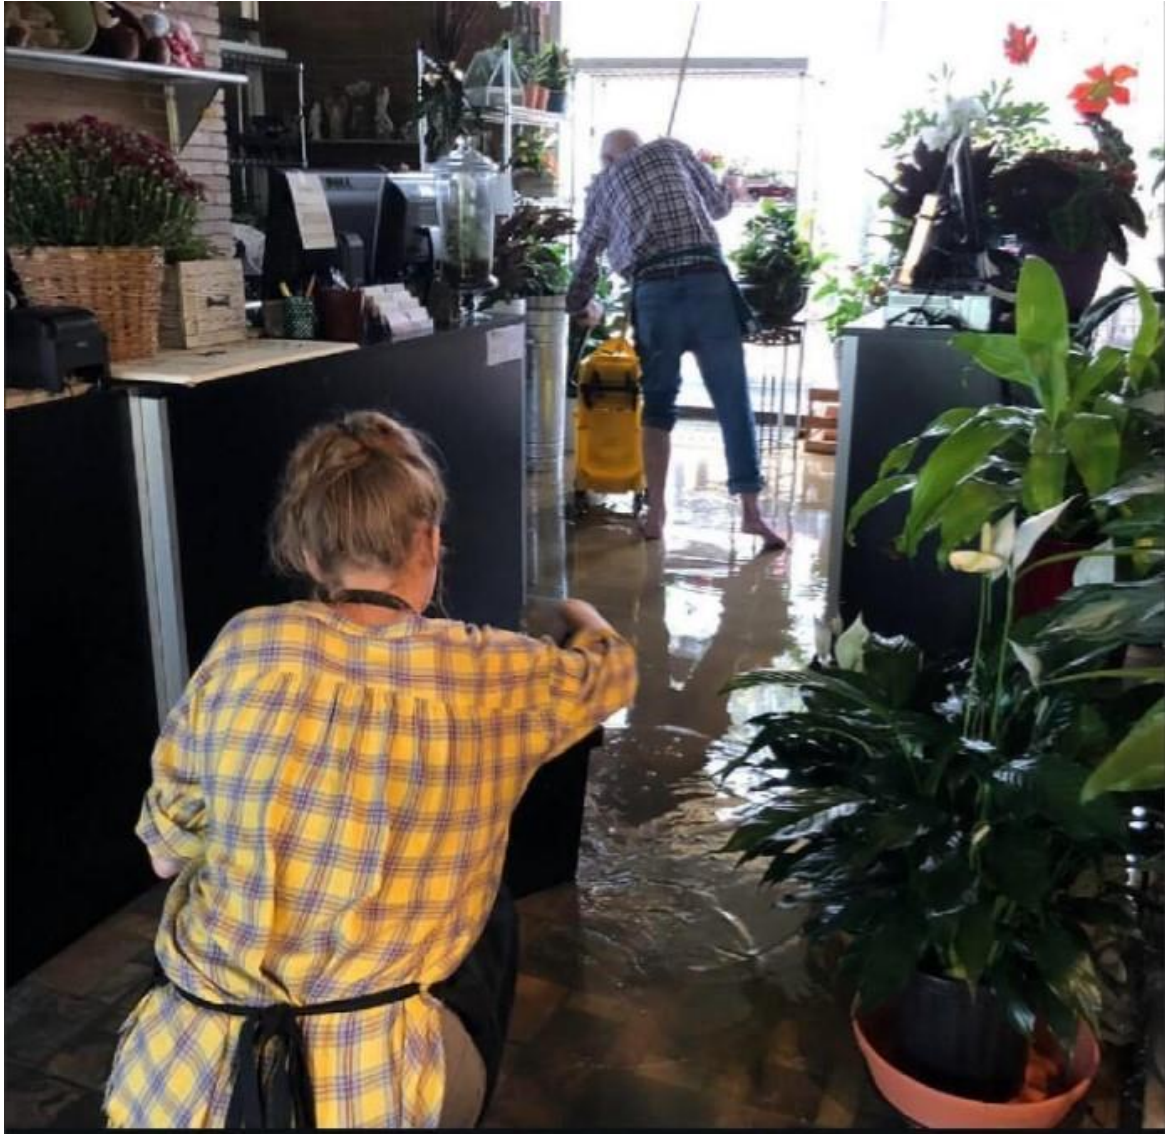
*Figure 3 – Cleanup of floodwaters and sediment deposition in 1953 Franklin Rd. SW.*
